Case History

Remove existing Foam Roof and replace with GacoRoofFoam and S20 System (Bldg B); repair existing Foam Roof (Bldg C).

St. Helena, CA

Franciscan Estates Winery

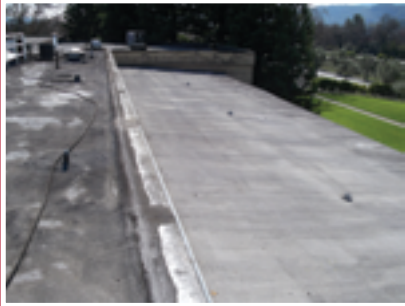
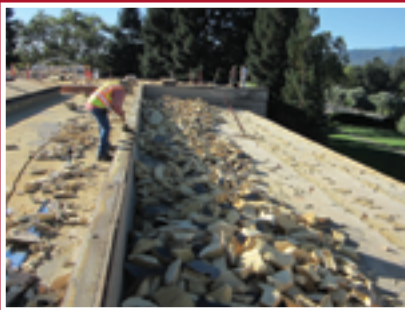
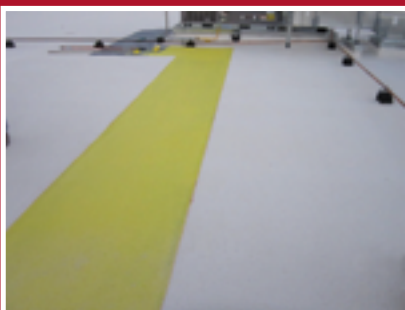
Failing roof replaced with **GacoRoofFoam and GacoFlex S20 Series.**

PROBLEM: The existing foam roofing on Building B at the Franciscan Estates, a well-respected winery in the Napa Valley for more than 40 years, had been repaired many times and needed to be completely replaced. Considering the amount and placement of HVAC equipment on their flat/low-slope 33,160 square foot roof, choosing the correct roofing materials to ensure proper drainage was a critical issue. In addition, the existing foam roof on adjacent Building C needed to be repaired before GacoRoofFoam and GacoFlex S20 Solvent-Free 100% Silicone Coating could be applied.

SOLUTION: Remove existing, poorly performing foam roofing down to the substrate, remove and replace HVAC equipment. Install 3" of GacoRoofFoam (2.7 lb) then coat with GacoFlex S20 Solvent-Free 100% Silicone Coating. This unique system provides a high R-value and forms a monolithic coating that fully adheres to the substrate to provide a seamless weather-tight seal.

Once the existing foam roof was removed, GacoFlex A4121 Acrylic Primer and GacoFlex E5320 2-Part Epoxy Primer/Filler was applied to the appropriate portions of the roof and parapet walls. Three inches of GacoRoofFoam 273 was then applied, followed by GacoFlex S2000.

The topmost flat part of the roof then had a maintenance walkway installed using GacoFlex SF2036 WalkPad.
