Case History

Type of Project / Name:	Combination EPDM & TPO Roof Restoration / Charles B. Wheeler Airport
Location:	Kansas City, MO
Specification:	RC-30-GF20 (GacoFlex S20 Silicone)
Contractor:	Clark and Associates
Customer:	Signature Flight Support
Problem to be Solved:	Existing combination EPDM & TPO roof was leaking.

Failing airport roof restored using *GacoFlex S20.*

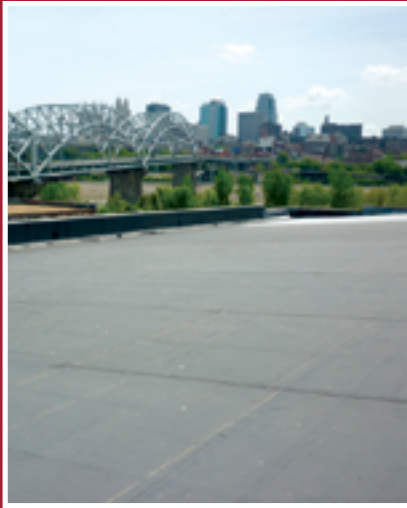
Before applying GacoFlex S20 the existing roof had significant deterioration.

Signature Flight Support operates the center, and they faced a major maintenance problem. The existing roof, a leaking layer of EPDM and a small portion of TPO, meant that the hangar hadn't been dry for the last 22 years. Pollution had literally etched holes in the existing EPDM.

The roof was laboriously cleaned of all pollutants, areas of rotting plywood deck were replaced, the roof was primed with Gaco Western E5320 primer, and the GacoFlex S20 silicone was applied. Signature Flight chose S20 in white, to reflect sunlight and keep their office area cooler in the summer. After the roof was cleaned seams that were opening were repaired and EPDM coming off a parapet wall was replaced with new EPDM. A complete GacoFlex roofing system that can be warranted includes D09 detergent, E5320 primer, and S20 coating.

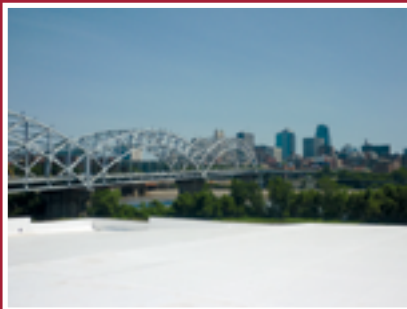
After applying GacoFlex S20 the roof surface is smooth and defect-free.
