Case History

Type of Project / Name: Flat Roof Restoration
Location: Haileah, FL
Specification: GacoFlex S20 Silicone Roof Coating System
Contractor: Florida Standard Roofing
Customer: BTU Electric Heaters
Problem to be Solved: Aged flat roof had significant ponding water issues.
Completion Date: June 2014

GacoFlex S20 Roof Coating System /
Flat Roof Restoration, Hialeah, FL

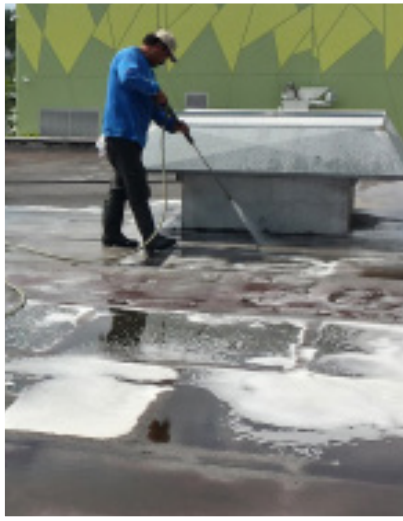
Using GacoWash Concentrated Cleaner to remove debris and oil.

All necessary repair work was performed and then the roof was washed with GacoWash Concentrated Cleaner to remove debris and oil and then allowed to dry. Next the GacoFlex E5320 2-Part Epoxy Primer/Filler was applied and allowed to dry. Seams, penetrations and areas surrounding roof drains were then sealed using GacoFlex SF2000 SeamSeal Solvent-Free Silicone Sealant and given ample time to cure. Next, GacoFlex S20 Series Solvent-Free 100% Silicone Coating was applied.

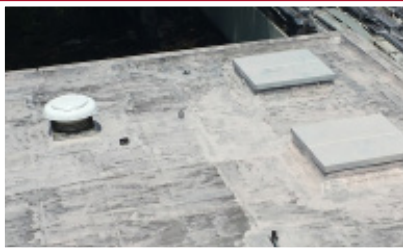
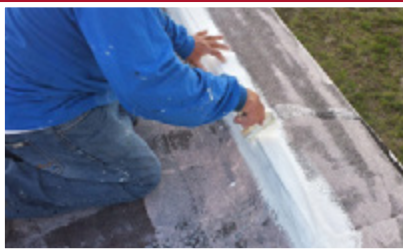
GacoFlex E5320 2-Part Epoxy Primer/Filler and GacoFlex SF2000 SeamSeal applied before GacoFlex S20.

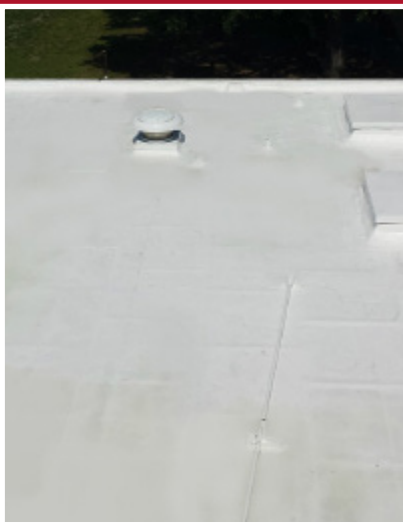
After the roof restoration was complete.
