# Case History

**Type of Project / Name:** Spray Foam Roof Restoration / Briarcliffe College  
**Location:** Bethpage, NY  
**Specification:** SI-22-GF  
**Contractor:** D'Onofrio General Contractors  
**Customer:** Briarcliffe College  
**Problem to be Solved:** Existing foam roof was cracked and leaking.

## Thorny roof problems smoothed out with **GacoFlex Silicone.**

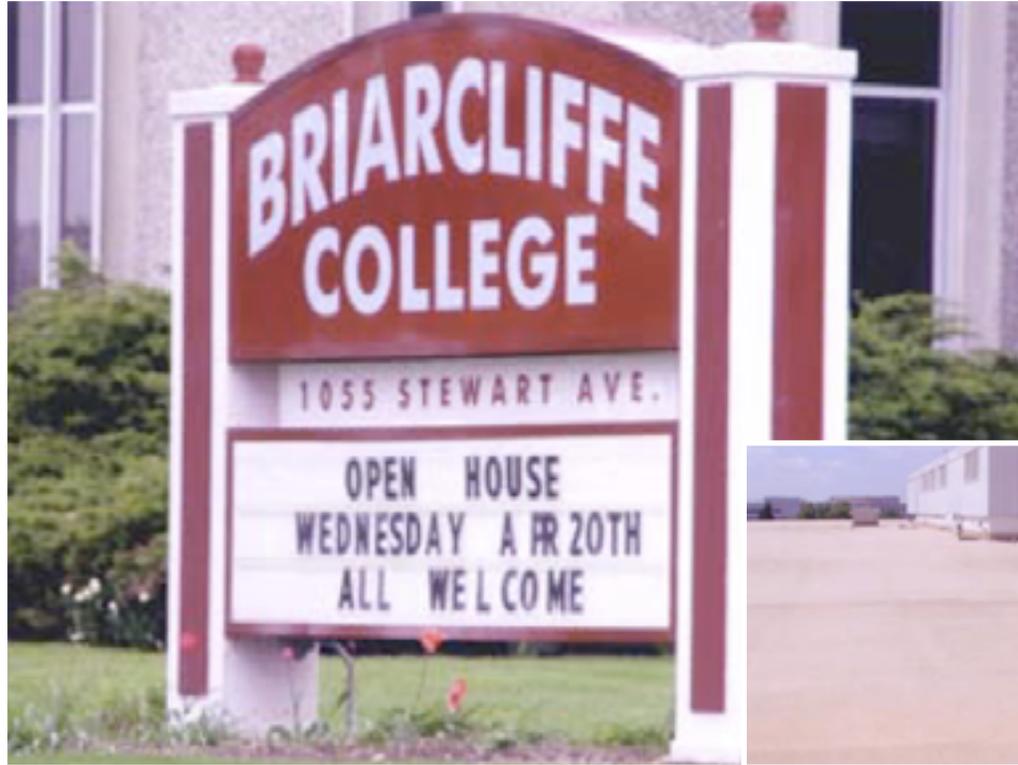
Installed 2005. In excellent condition nearly ten years later!
